Manhole Inspection Summary

Manhole # S25GG1023MH

Insp Date: **1/23/07 9:49 AM**

Location Address: **4018 HICKORY AVE**

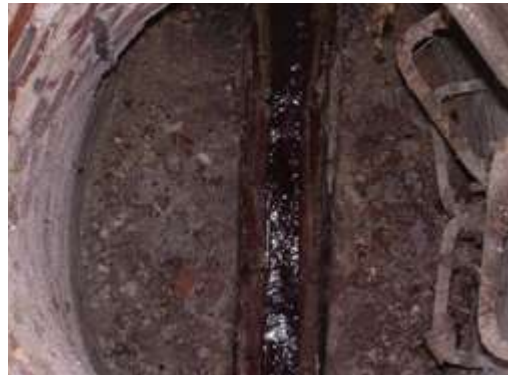
Top View

Corroded steps. Evidence of surcharge - Bench debris.

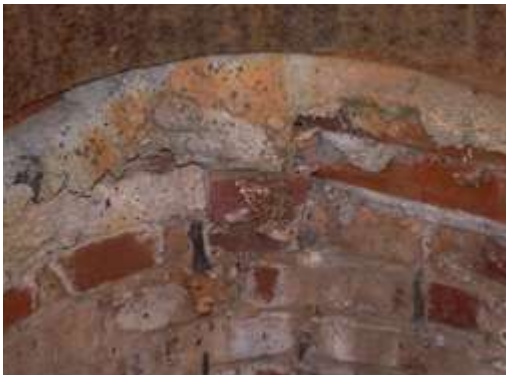
Defect

Infiltration: ☐ None ☒ **Joint** ☐ Cracks ☐ Mortar ☐ Roots ☒ **Wall**

Adjustment infiltration.

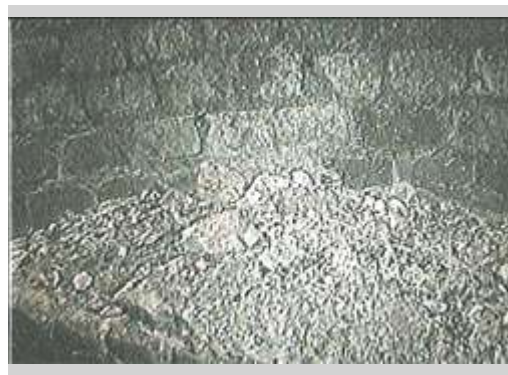
Defect

Condition: ☐ Sound ☐ Cracked ☐ Root Intrusion ☐ Loose Brick ☒ **Deteriorated**

Infiltration: ☐ None ☐ Joint ☐ Cracks ☒ **Mortar** ☐ Roots ☒ **Wall**

Barrel deterioration and infiltration. Bench debris.

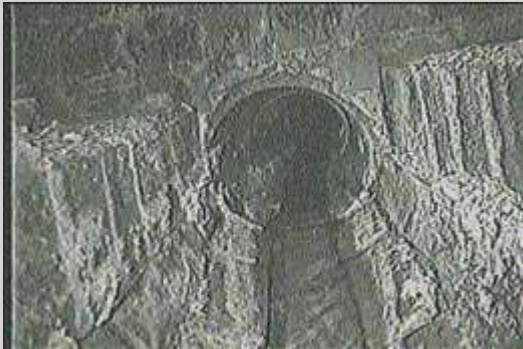
8 in. Circular Gravity Sewer Pipe Out @ 12 O'Clock

Deposits: ☐ None ☐ Mud ☐ Sludge ☐ Debris ☒ **Grease**

Silt Depth: **0** (in.) Deposits Extent: **Medium**

Infiltration: **Evidence** Pipe Seal Cond: **Unknown**

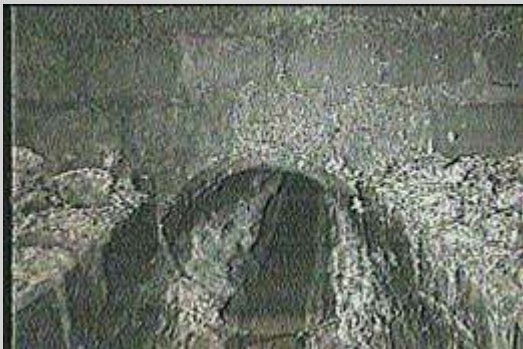
8 in. Circular Gravity Sewer Pipe In @ 6 O'Clock

Deposits: ☐ None ☐ Mud ☐ Sludge ☐ Debris ☒ **Grease**

Silt Depth: **0** (in.) Deposits Extent: **Medium**
